INTERIM REPORT

**B-58 AIRCRAFT AVIONIC SUBSYSTEMS
RELIABILITY AND MAINTAINABILITY
IMPROVEMENT PROGRAM**

June 1965

ARINC RESEARCH CORPORATION

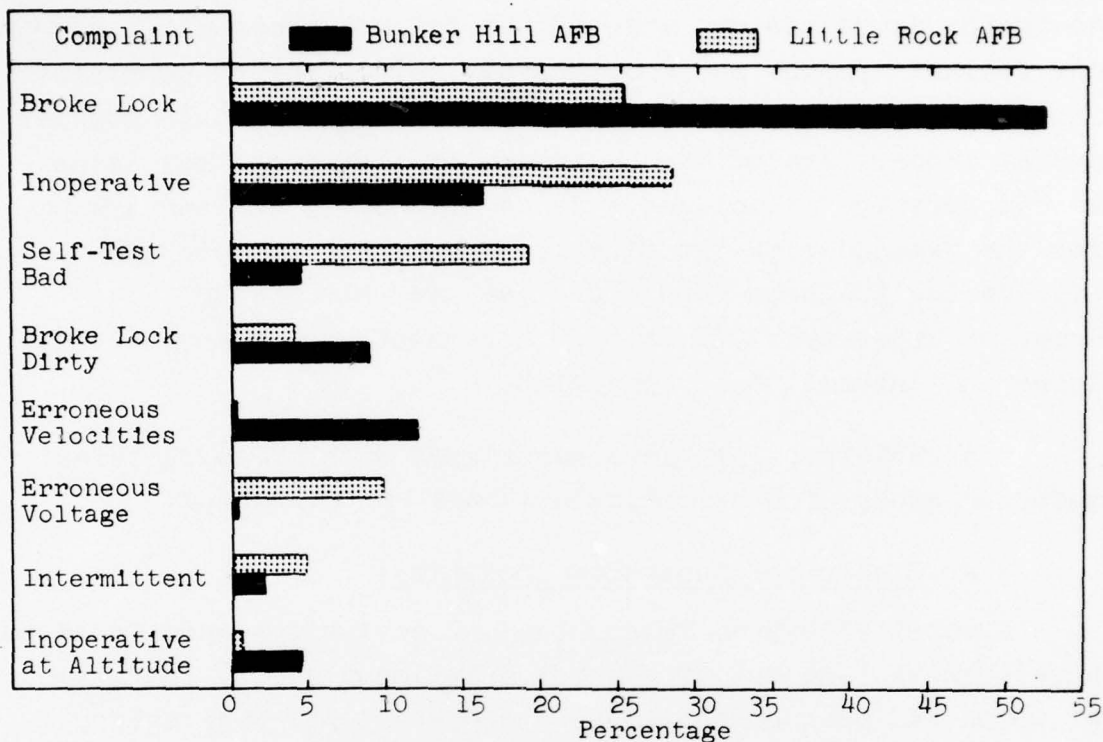
FIGURE 3-1

- (1) Of all complaints, the broke-lock complaint occurs most frequently: 52.5% at Bunker Hill AFB and 25.0% at Little Rock AFB.
- (2) Marginal Doppler systems represent the second largest group of complaint categories. (Marginal systems are those which supposedly operate well when tested on the ground but do not function in the air.) Usually they are reported as inoperative, inoperative at altitude, or intermittent. A grouping of these categories accounts for 21% of

MAJOR IN-FLIGHT COMPLAINTS FOR THE APN-113 AT
LITTLE ROCK AND BUNKER HILL AIR FORCE BASES

- (3) Dirty-unlock complaints are about one-sixth as frequent as simple-unlock complaints: 8.5% at Bunker Hill AFB and 4.9% at Little Rock AFB. These values include the erroneous-velocities complaint, a condition that precedes "dirty unlock" if the Doppler is not deactivated soon enough.

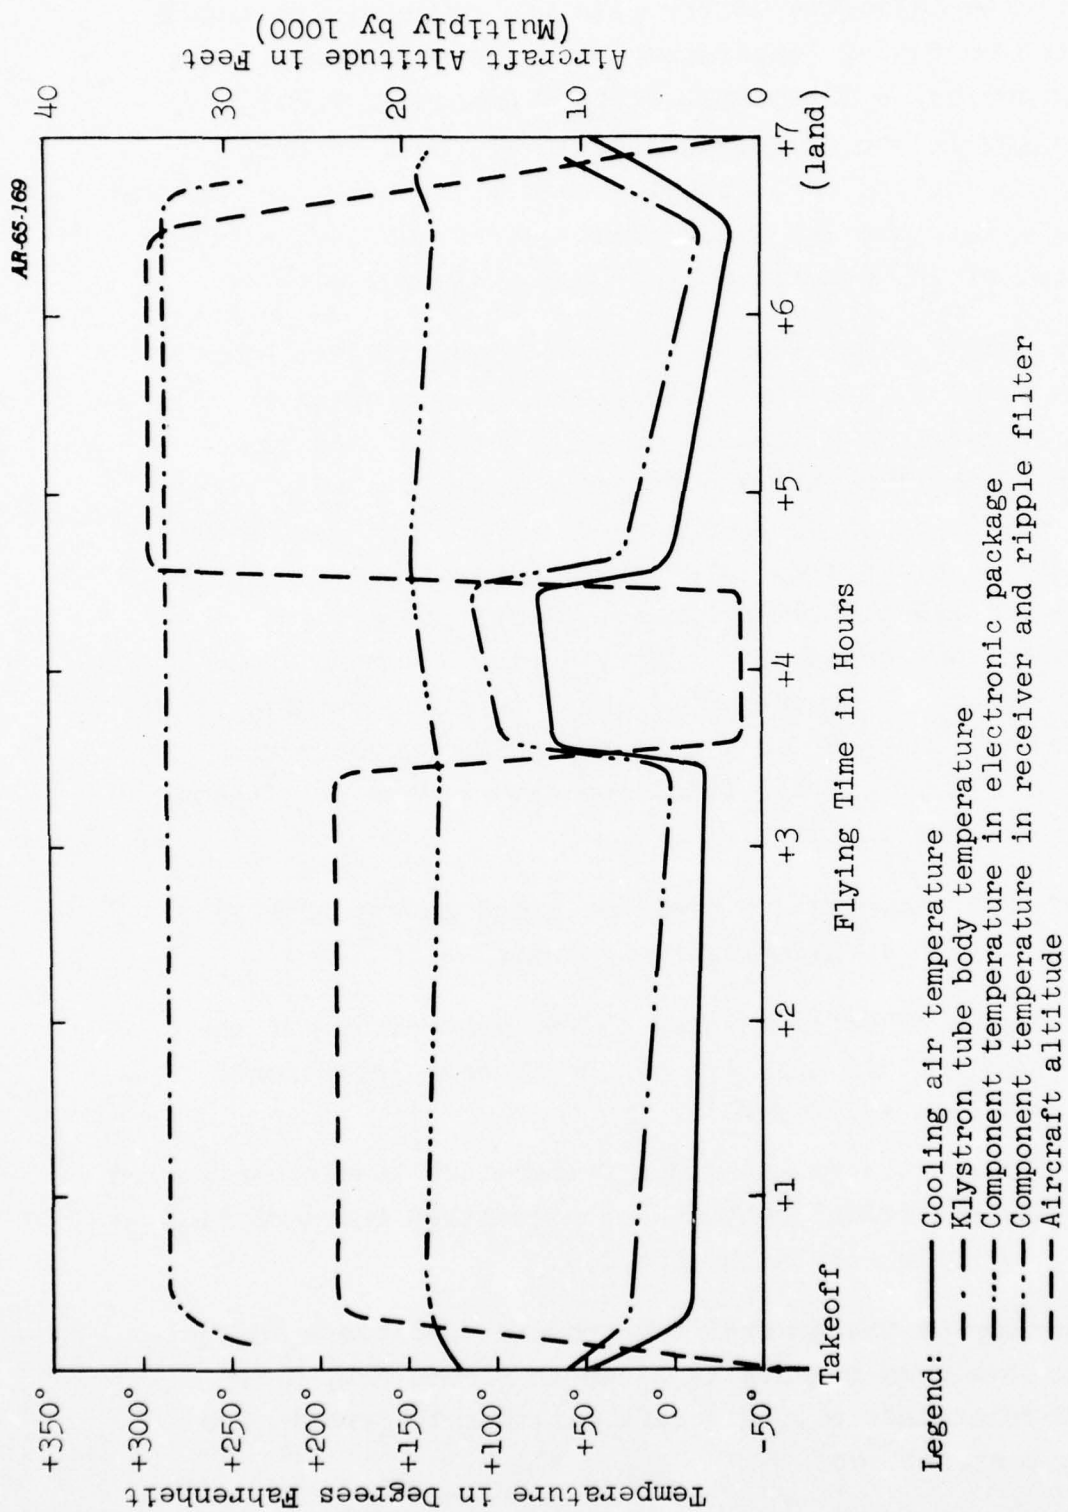
FIGURE 3-2

Test results indicated that the temperatures at high altitudes were too low for optimum APN-113 performance. Also, in cases of marginal alignment or adjustment of APN-113 components, the temperature deficiency would probably result in in-flight failures that could not be verified during ground tests, which are performed at higher temperatures. An interim report on the APN-113 temperature-recorder project was delivered to the contracting agency during December 1964.³⁸ A final report on this subject is planned after the flight tests are completed, in accordance with the WRAMA Doppler Radar Improvement Plan, in order that temperature data from these tests may also be included.

A summary of the general temperature conditions in the APN-113 radome compartments is given in Figure 3-2, which shows the relationship of aircraft altitude to certain LRU operating temperatures.

TEMPERATURE CHART FOR APN-113 RADOME COMPARTMENTS

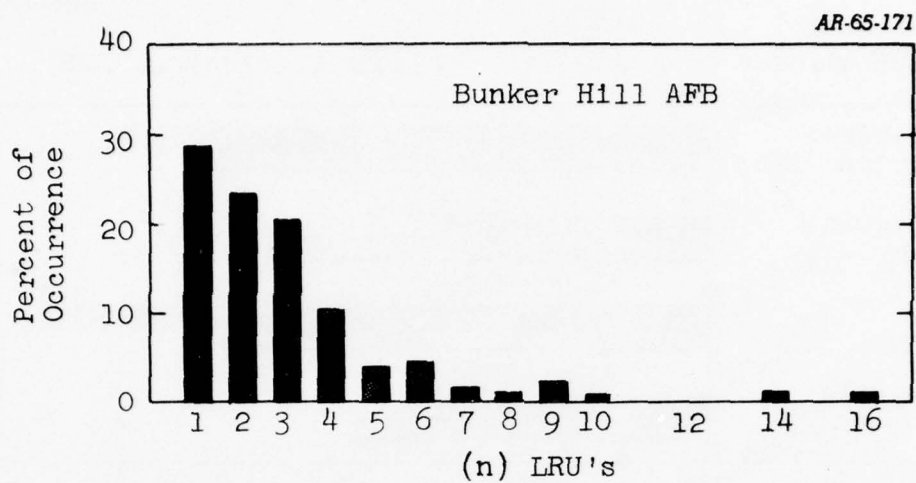
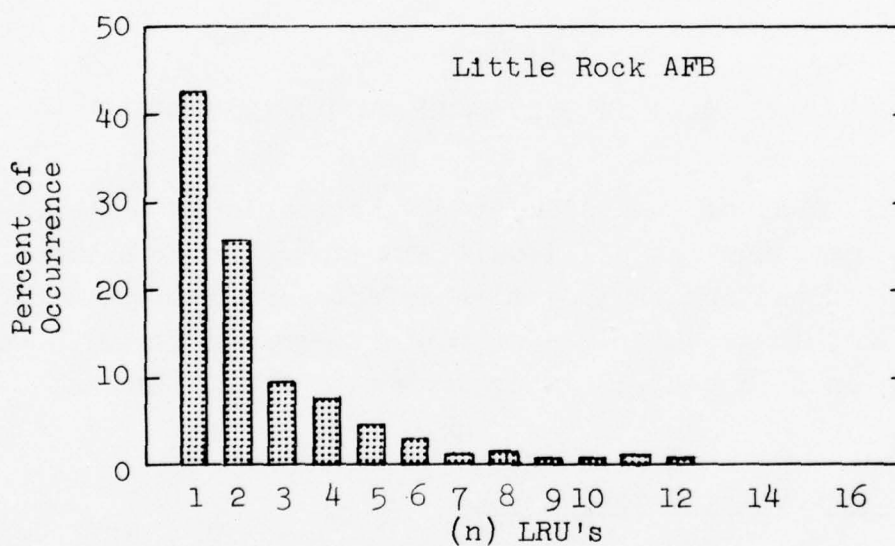
FIGURE 3-4

The maintenance problem is further identified by an examination of the quantity of LRU's involved in repair actions. (Figure 3-4 shows the distribution for each base.) There are a maximum of 19 separate items, including 3 Frequency Trackers per subsystem, which are identified as LRU's in the APN-113. In a complex system that has extraordinary interface or harmonization ("marriage") problems, an average of three LRU's per functional loop with a maximum of six LRU's per loop, involvement of three or four LRU's per repair action is not unreasonable. However, the records of both bases show that nearly one-fourth of all events involve from 4 to 16 LRU's per repair action. This indicates recurring difficulty in locating defective LRU's at the flight-line level or use of faulty LRU's as replacements, or both.

FREQUENCY DISTRIBUTION OF THE NUMBER OF
LRU'S INVOLVED PER APN-113 MAINTENANCE ACTION

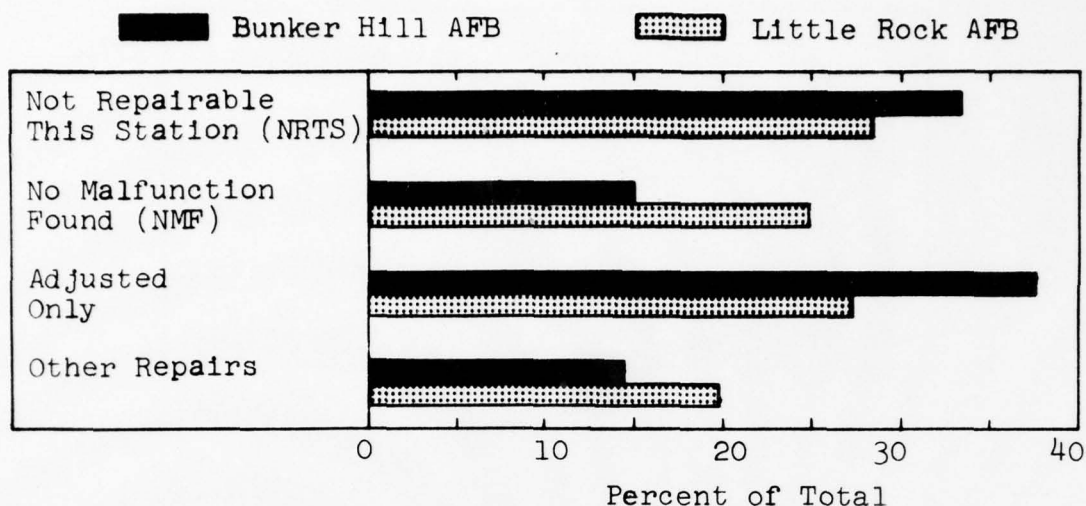
FIGURE 3-5

Further evidence of maintenance difficulties is provided by the data in Figure 3-5, which gives a distribution of LRU major-action categories. At least 20% of all APN-113 LRU's involved in maintenance events are found not to be defective. This is an optimistic figure, since this particular display includes LRU adjustments and/or repairs that were completed without LRU removal, and the no-malfunction-found category applied only to LRU's removed from an aircraft. Also, according to Figure 3-5, more than 30% of all LRU actions involve adjustments or alignments only.

DISTRIBUTION OF LRU MAJOR ACTION CATEGORIES

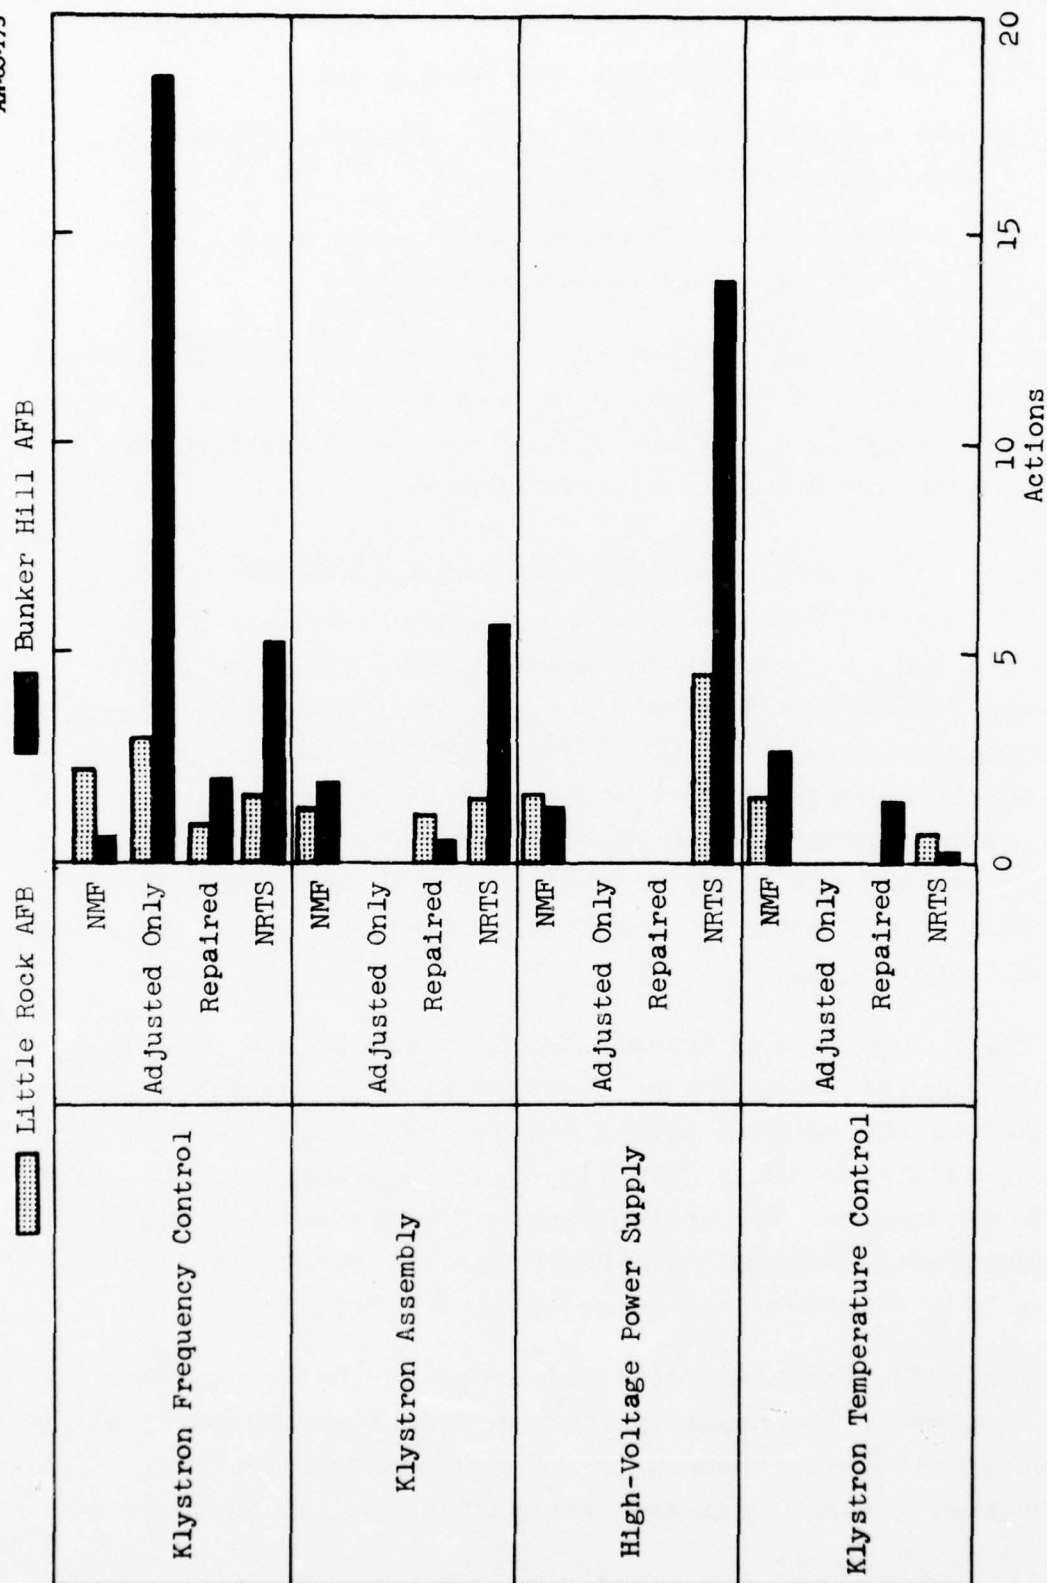
FIGURE 3-6

The nature of the transmitter loop makes it difficult to isolate its failures, and as a result there is a high percentage of multiple LRU actions during repair. The loop accounts for a substantial portion of APN-113 repair actions. Distribution of LRU actions per 1000 flight hours for transmitter functions is described in Figure 3-6. PSDP removals related to Transmitter Loop Functions are shown in Figure 3-7.

The study revealed deficient areas in the transmitter loop. However, the majority of them can be corrected by slight, but very effective, changes to the equipment or testing procedures. These areas are discussed on an LRU basis below.

TRANSMITTER LOOP FUNCTION - DISTRIBUTION OF LRU ACTIONS PER 1000 FLIGHT HOURS

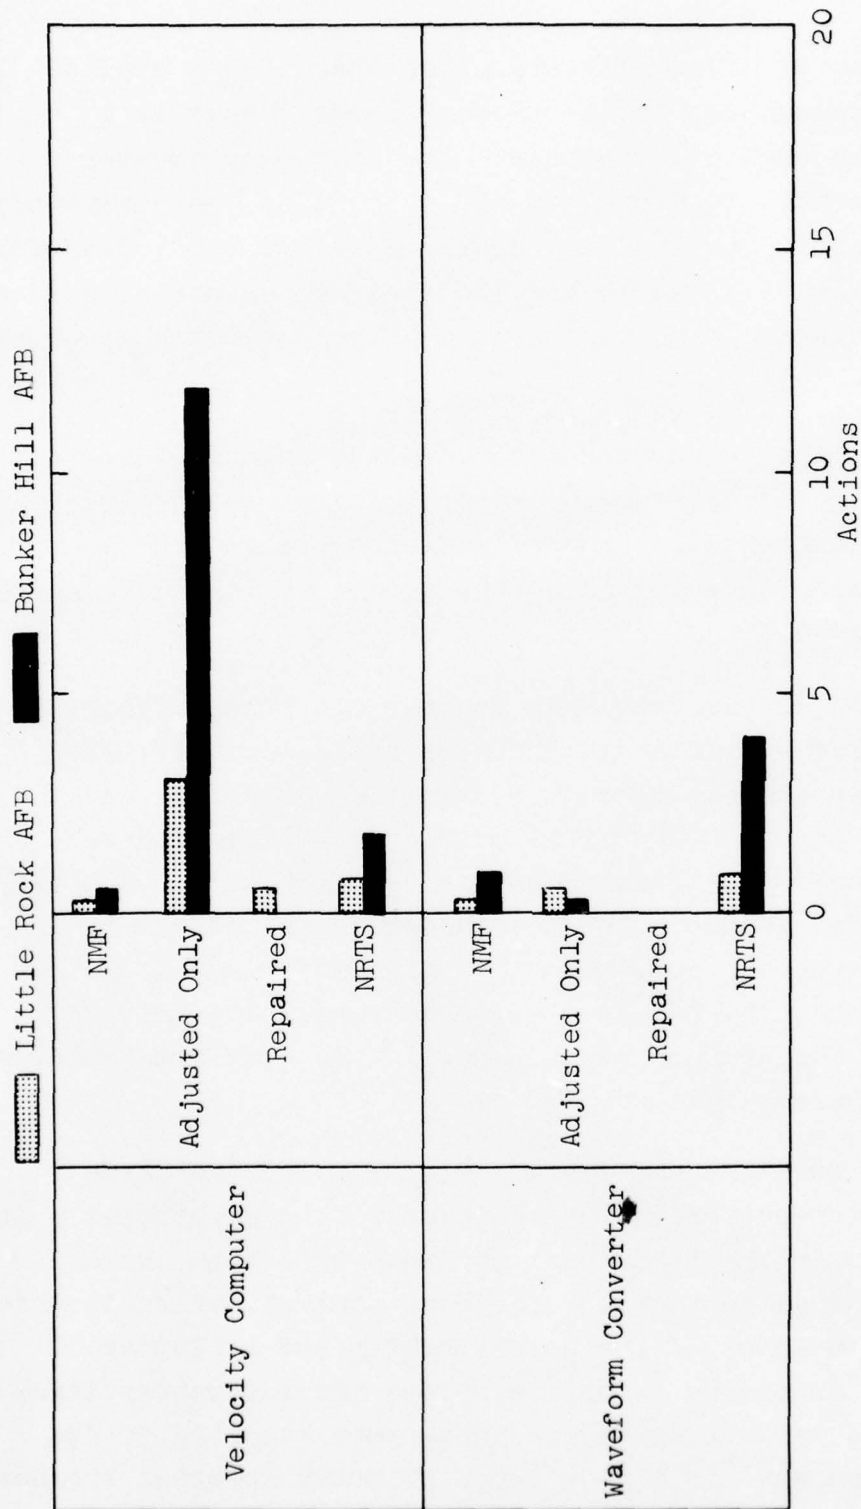
FIGURE 3-9
DATA CONVERSION LOOP FUNCTION - DISTRIBUTION OF LRU
ACTIONS PER 1000 FLIGHT HOURS

Distribution of LRU actions per 1000 flight hours related to this Data Conversion Loop Function are shown in Figure 3-9. PSDP LRU actions related to this function are shown in Figure 3-7.

Investigation revealed some deficiencies within the Data Conversion Loop Function. The output of the Frequency Trackers is coupled to the Waveform Converter, where it is

first processed by a squaring amplifier stage, then applied to a frequency-counting device whose voltage output is a function of the applied frequency. The frequency counter subassembly is held to extremely close counting (approximately 0.1%) and linearity tolerances (approximately 0.01%); therefore, the required accuracy can be obtained only by maintaining close control of operating temperature of the semiconductor counting elements.
